Subject : RECCE PATROL REPORT (VICTORY) : FORWARDING OF

RECCE PATROL REPORT (VICTORY)

THE ROAD KIGALI - GATUNA REPAIR AND MAINTENANCESReference:

ANNEX A TO
ENGR RECCE REPORT
DATED 21 NOV 94

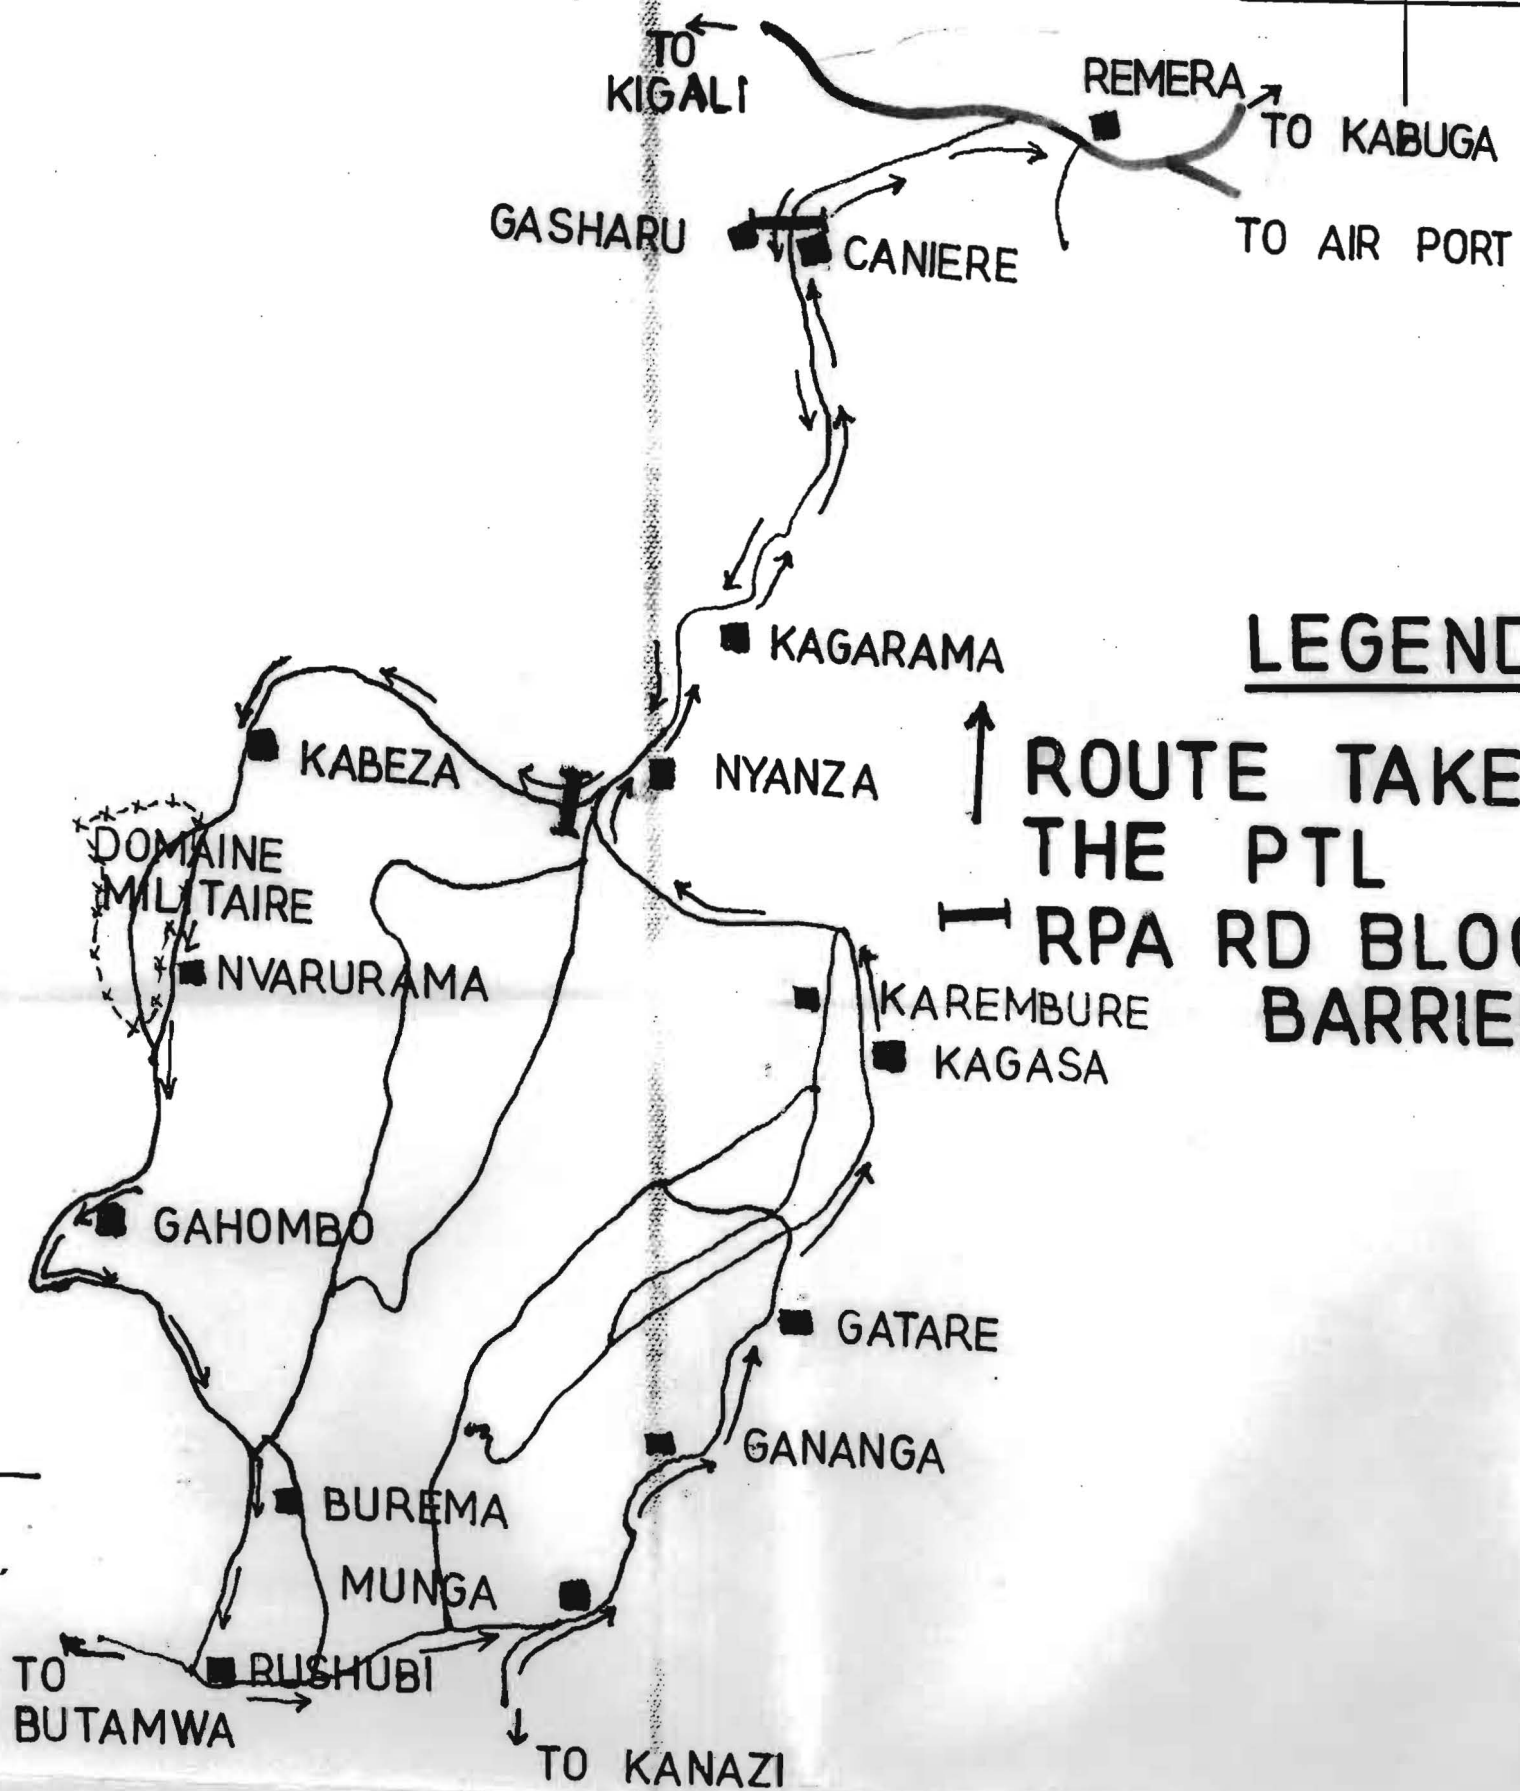
ROUTE CHART

- (b) 1xANPRC-25 set for comm with Bn HQ.
6. ROUTE. The route taken by the ptl is shown in the sketch att (Appx P).
7. TERRAIN. The terrain is generally hilly with heights upto 1775 mtrs with gentle slopes.

(g) The static barriers manned by RPA are shown in the sketch.
